Cornwall - Damaging Swell of 6th January 2014

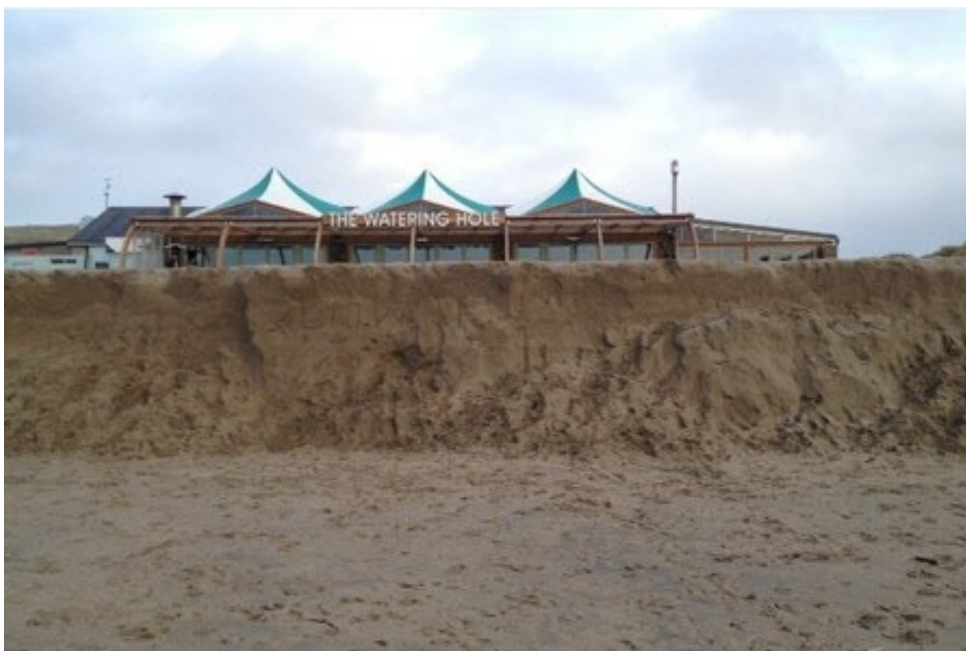
This is not to take away just how destructive the evening high tide of 5th, and the morning high tide of 6th were. At Perranporth there was a 12-15 feet cliff in the sand cut out at the high tide limit just in front of the Watering Hole in just these two tides. The wind was not a directly onshore NW, the direction you would normally expect to be most erosive, but from a relatively sheltered WSW direction.

It may be that the extreme erosion in this case was due to concave refraction. Normally the headland to the west of Perranporth offers some protection, but these very long wavelength storm waves refract to a greater extent than smaller wavelength swells. Concave refracting (focusing) may well have occurred just to the east of the headland. It is interesting that Towan beach, Newquay, in a similar position to the east of Pentire was similarly badly hit. The road to the Blue Reef Aquarium was badly damaged.

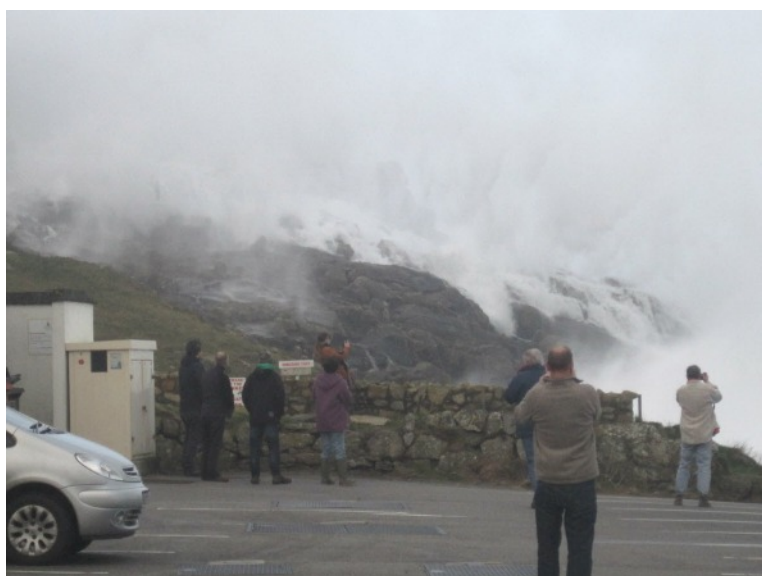
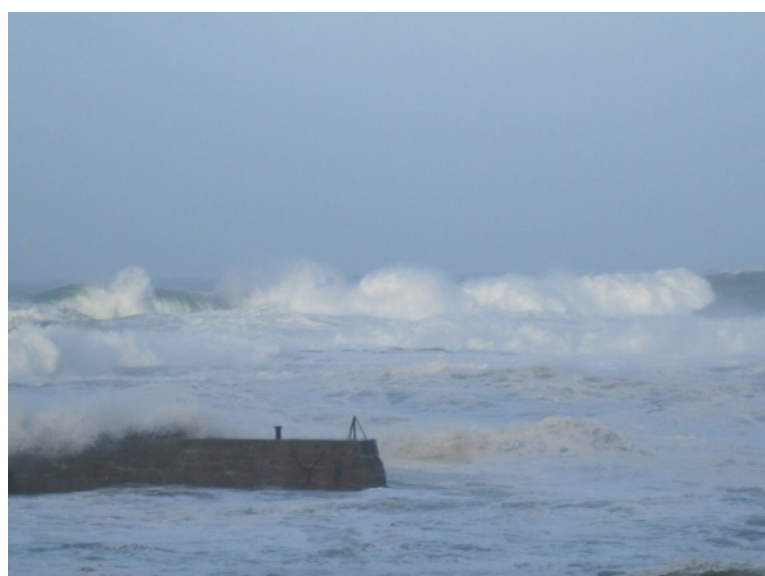
On January 6th I was at Sennen observing the conditions, here are a couple of photographs.

As is normal the larger waves come in sets, but at around 09:50 there were two consecutive waves significantly larger than any others in the previous 30 minutes or so, causing a big reaction from the crowd of onlookers. These occasional 'supersets' are a not unusual feature and are down to constructive interference of 2 different wavelength swells, very well known to surfers. As the data buoys measure significant wave height averaged over a period of 20 minutes, these supersets, even if they hit the buoy, would only have a minimal affect on the significant wave height. However, it may well be that on this occasion they were responsible for some of the extreme damage. As well as some man made features, such as the 'Pepper Pot' on the end of Portreath pier, a number of natural coastal features have been significantly changed by the storm.
